Geofabric Pull Out Test Report

Test Date 25 November 2022
Tester Osama Mughrabi
Location 667b Great South Road, Penrose

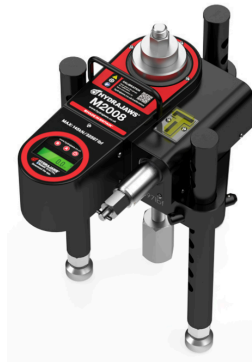
Fig 1. Loading device

The Hydrajaws Model 2008 device was used as the loading device. The device has a loading capacity of up to 145 kN and is normally used for heavy duty pull testing of anchor bolts. The device is shown below.

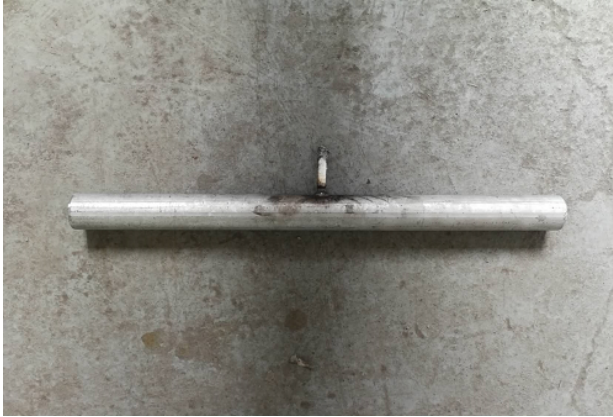
Loading pipe

A 50 mm diameter steel pipe was used as a mean to transfer the pull out force from the loading device to the embedded geogrid. A 12 mm diameter threaded rod was welded at the middle of the pipe, which was used to attach the loading device to the loading pipe. The loading pipe acted similar to a bodkin in actual applications, and was also used to stitch an extra piece of geogrid to the casted one. The loading pipe and the test sample after stitching the extra piece of geogrid are shown below.

Fig 2. Test setup before fixing the loading device

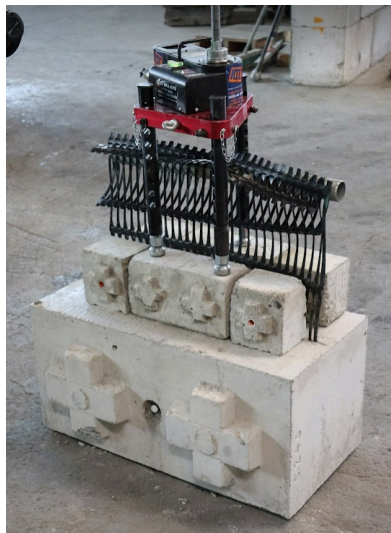
Fig 3. Loading device mounted at the backside of the block

After stitching the geogrid, the loading device was mounted at the backside of the block and elevated using small concrete blocks as shown below.

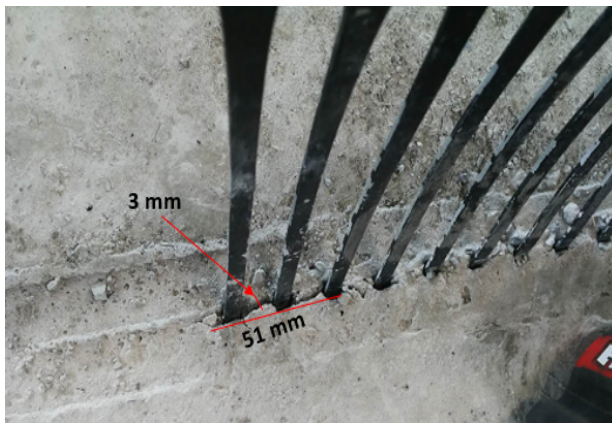
Left side crack

The cracks near the edge of the geogrid at the end of the test and after removing the loading device are shown in the figure below.

Fig 4. Cracking near the edges of the geogrid

Table 1. Ultimate limit state test observations	
Load (kN)	Observation
80 kN	The stretching of the geogrid was visible at the middle. However, since measuring the length was hard with the test setup, it is not possible to decide the load at which the stretching started.
130 kN	Cracking sounds were heard. However, other than the 2 cracks near the edge of the geogrid, no other cracks were visible.

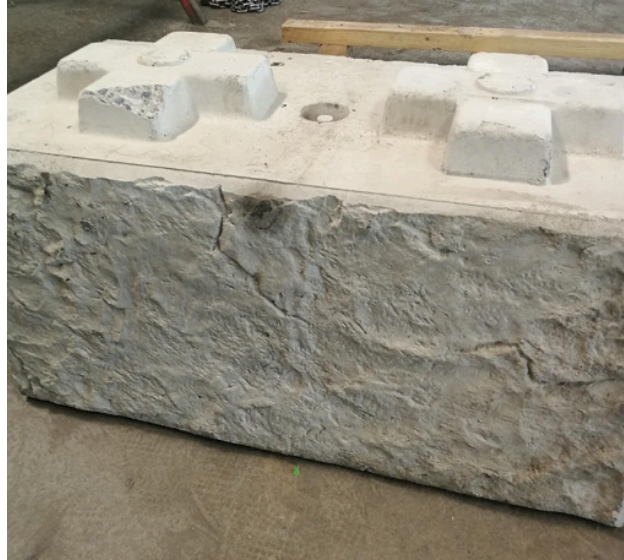
Fig 5. The face of the block after testing

The face of the block was inspected to check if the cracks propagated to the other side. No signs of cracking as shown in the below figure.

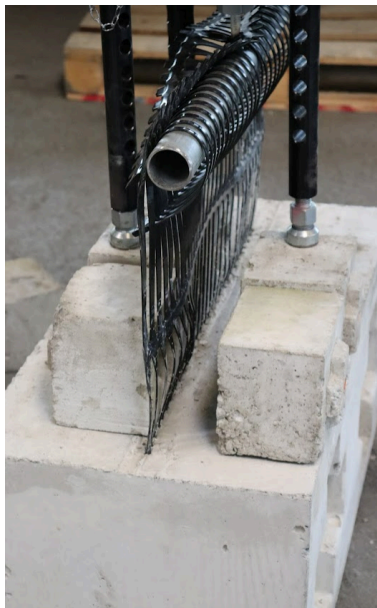
Overall view of the geogrid at 80 kN

Geogrid stretching was observed at the middle of the geogrid. This means that most of the applied load was concentrated at the middle when the geogrid started stretching. This can also explain the slow propagation of the cracks near the edge of the geogrid. The status of the geogrid at 80 kN is shown in the figure below.

Fig 6. Status of the geogrid at 80 kN
